ATTACHMENT TO L-1101
06 JULY 1966
PAGE 1

ROAD CONDITIONS
PANHANDLE AREA, LAOS

NATIONAL PHOTOGRAPHIC INTERPRETATION CENTER
ROAD CONDITIONS
PANHANDLE AREA, LAOS

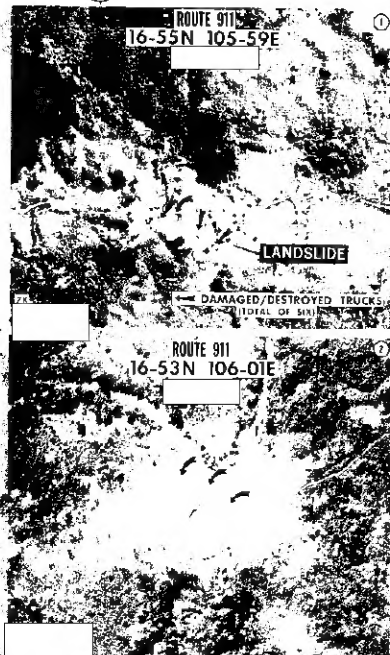
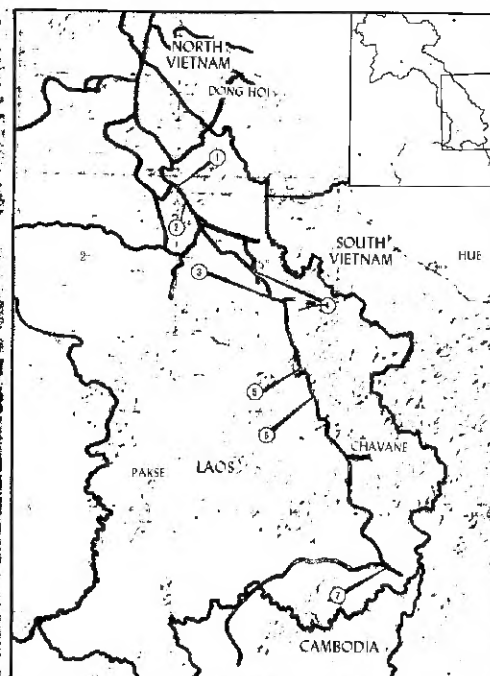
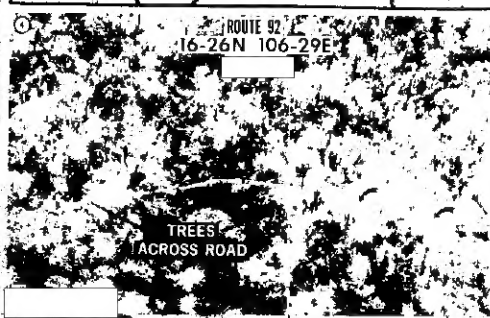
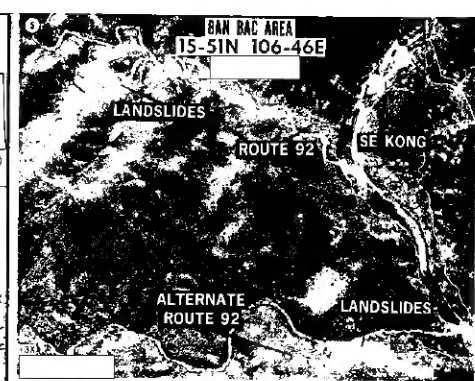
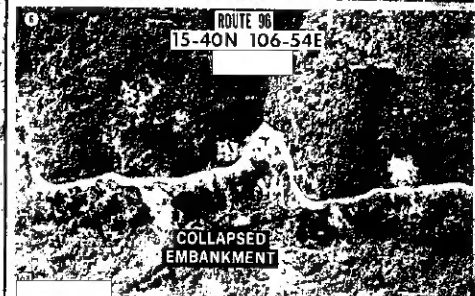
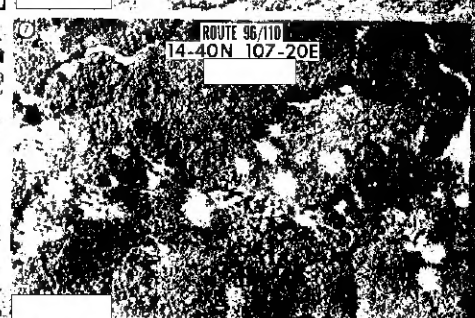
THIS BRIEFING BOARD DEPICTS ROUTES IN THE LAOTIAN PANHANDLE THAT HAVE BEEN RENDERED UNSERVICEABLE BY AIR STRIKES AND NATURAL DETERIORATION.

REVEALS THAT ROUTE 911 HAS BEEN INTERDICTED AT THE FOLLOWING LOCATIONS (NOT ALL SHOWN ON GRAPHIC):

1702N 10558E	(UTM XD026842)
1701N 10555E	(UTM WD978818)
1659N 10555E	(UTM WD982795)
1655N 10559E	(UTM XD062717)
1653N 10601E	(UTM XD088670)

REVEALED THAT THE INTERDICTION POINTS AT THE LAST TWO LOCATIONS WERE BEING BY-PASSED).

A TOTAL OF SIX DAMAGED/DESTROYED TRUCKS ARE OBSERVED ON ROUTE 911 AT 1655N 10559E.

REVEALS THAT ROUTE 92 HAS BEEN INTERDICTED AT 1618N 10637E (UTM XD737026). IN THE AREA OF BAN BAC, NEAR THE SE KONG (RIVER), ROUTE 92 AT 1551N 10646E (UTM XC901538) AND ALTERNATE ROUTE 92 AT 1550N 10645E (UTM XC888523) ARE BOTH UNSERVICEABLE DUE TO NUMEROUS INTERDICTIONS AND LANDSLIDES.

AND FALLEN TREES ON ROUTE 92 AT 1626N 10629E (UTM XD592190), APPROXIMATELY TWENTY-ONE NM SOUTHEAST OF SEPONE.

[REDACTED] REVEALS A PARTIALLY COLLAPSED EMBANKMENT FROM WEATHERINGS ON ROUTE 96 AT 1540N 10654E (UTM YC033333), APPROXIMATELY TWELVE NM SOUTHEAST OF BAN BAC.

[REDACTED] DEPICTS INTERDICTION POINTS ON ROUTE 96/110 AT 1440N 10720E (UTM YB514236), APPROXIMATELY TWELVE NM WEST OF THE TRI-BORDER AREA OF CAMBODIA, LAOS, AND SOUTH VIETNAM.

IT IS NOTED THAT MOST OF THE REFERENCED INTERDICTIONS COULD BE BY-PASSED WITH A MINIMUM OF EFFORT; HOWEVER, WITH THE EXCEPTION OF THE TWO BY-PASSED INTERDICTIONS ON ROUTE 911, NO ATTEMPTS ARE OBSERVED.
